TESTING OF BALLGRAB ANCHOR CONNECTOR

REPORT No. 2002-3263

DET NORSKE VERITAS

Date of first issue: 2002-07-31	Project No.: 71521012	DET NORSKE VERITAS REGION NORGE AS <i>Structural Integrity and Laboratories</i> Veritasveien 1, N-1322 HØVIK, Norway Tel: +47 67 57 99 00 Fax: +47 67 57 99 11 http://www.dnv.com Org.No: NO 959 627 606 MVA
Approved by: Elisabeth Heggelund Tørstad Head of Section	Organisational unit: Structural Integrity and Laboratories	
Client: BSW Limited Design & Engineering	Client ref.: Ian Brown

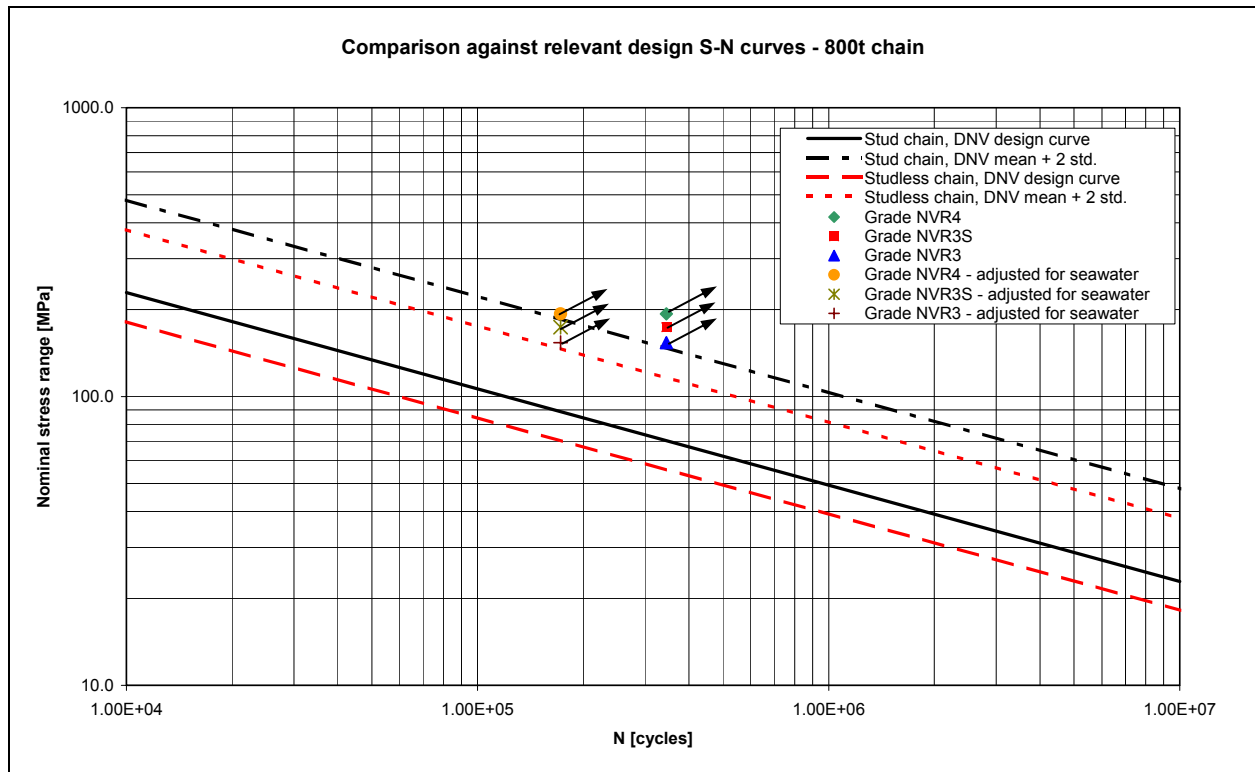
Figure 2 Corresponding chain stress ranges derived from test results.

The results in Figure 2 are presented as the stress range in a chain connected to the anchor connector, i.e. the chain and the connector are subject to the same dynamic load because they are linked together. The chain will therefore have to have a fatigue capacity as presented, to be able to withstand the same fatigue loading as the connector.

The results presented in Figure 2 shows that the corresponding stresses in the different types of chains are exceeding the two design curves and the derived upper bound curve for studless chain. The upper bound curve for stud chain is not exceeded for the corresponding chain stress ranges that are adjusted for seawater. It should be noted that there were no indications of failure of the 800t anchor connector, and the capacity of the connector may therefore be larger.

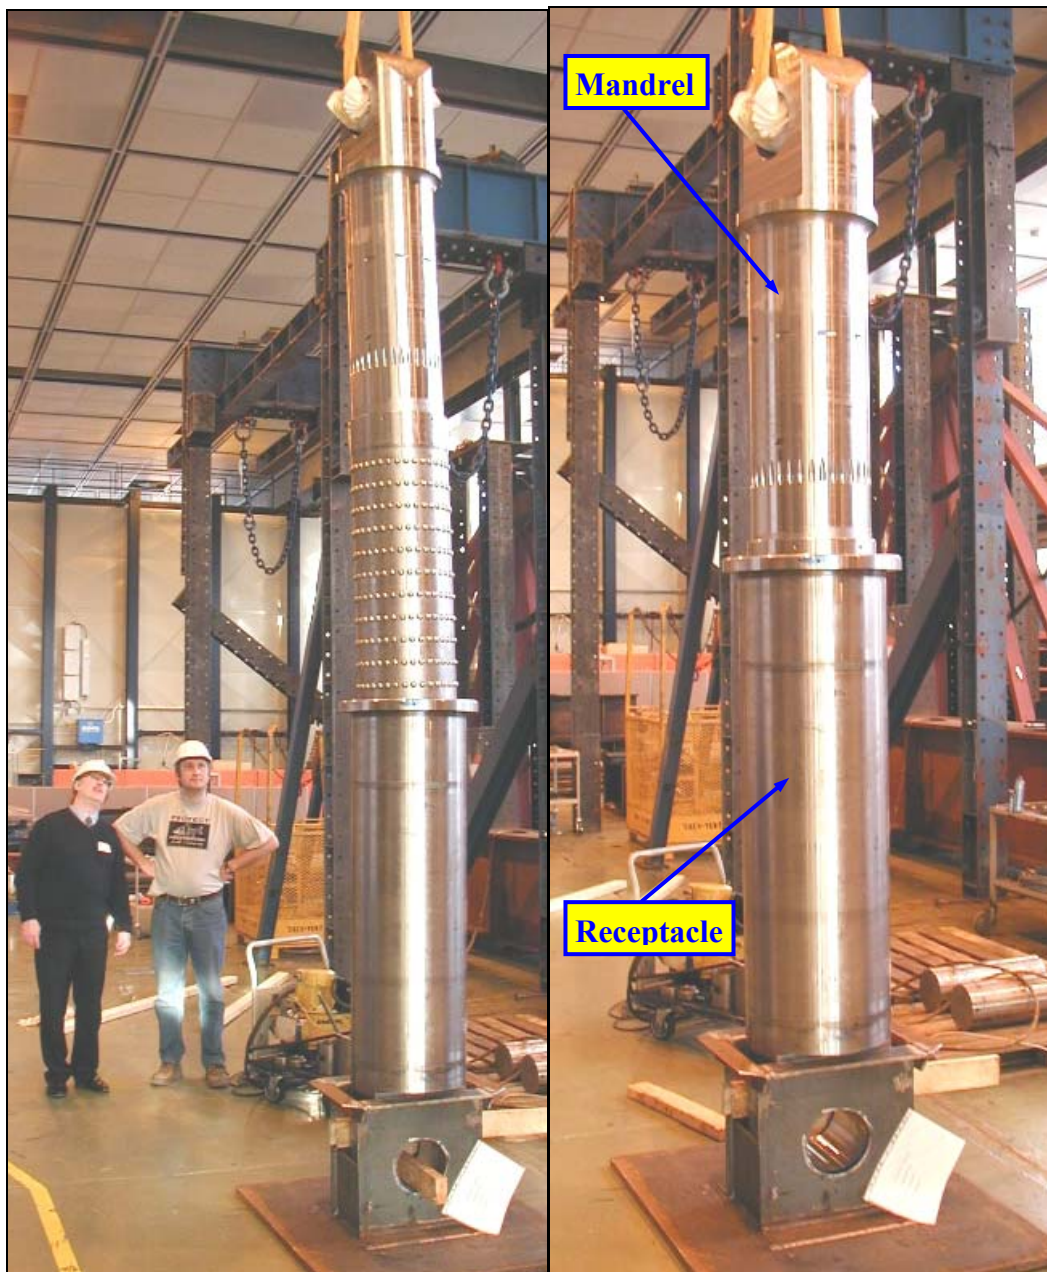
The main parts of the connector are the mandrel (male) and the receptacle (female), as shown in Figure 3. The mandrel on both test specimens had 12 rows of balls.

**Figure 3 To the left: 1500t MBL Ballgrab Anchor Connector being connected.
To the right: 1500t MBL Ballgrab Anchor Connector after connection.**

- 1 off 1500t MBL Ballgrab Anchor Connector, shown in Figure 3.
- 1 off 800t MBL Ballgrab Anchor Connector.

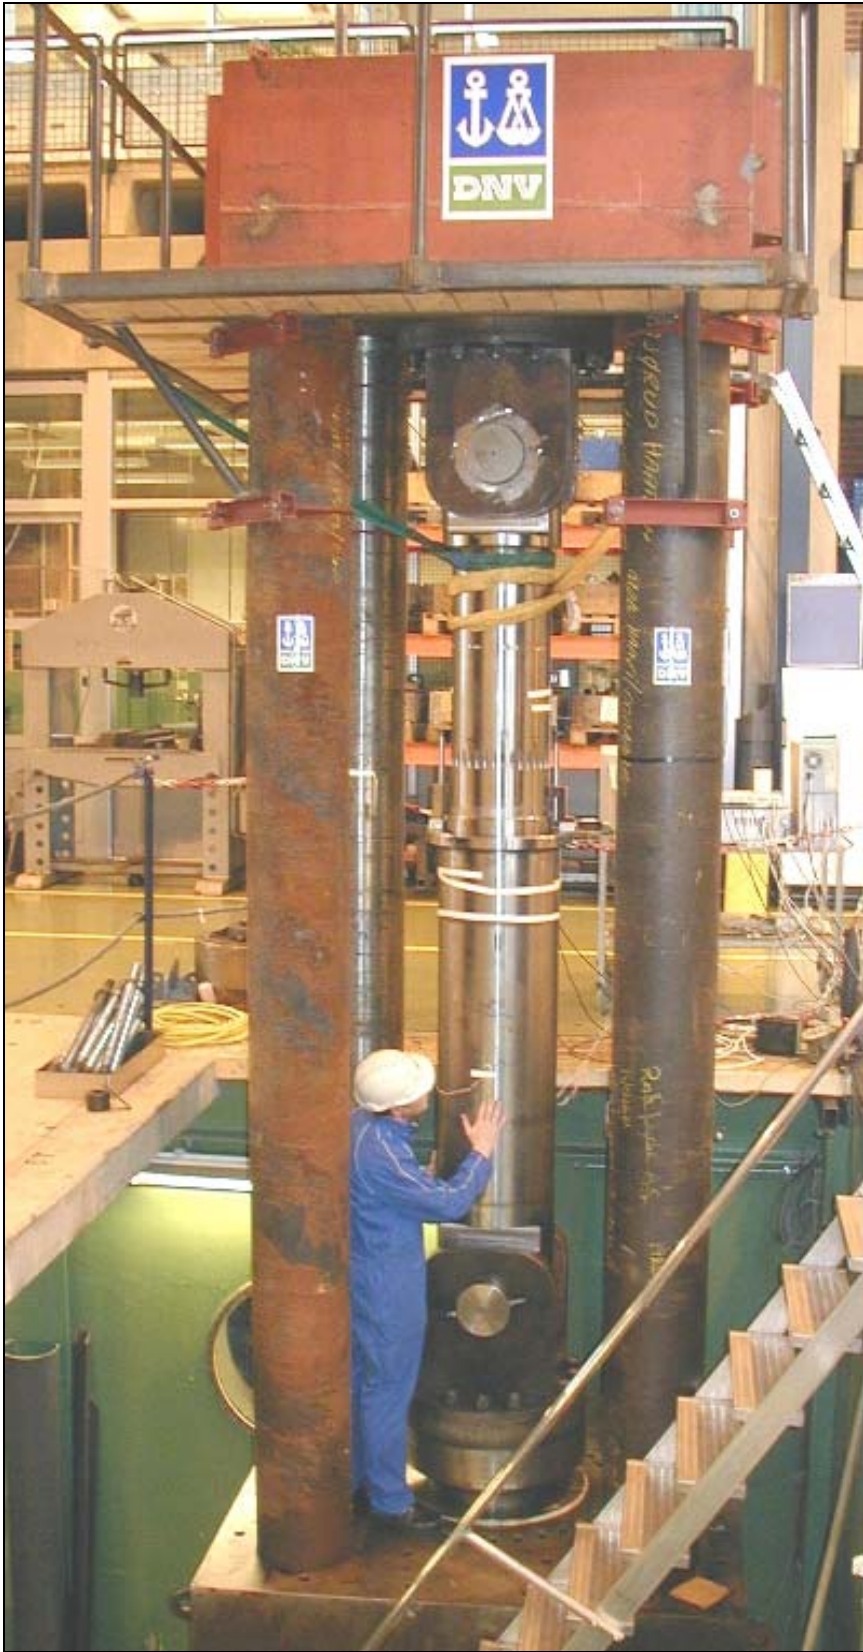
Figure 6 Fatigue testing of 1500t MBL Ballgrab Anchor Connector.

The tests were carried out in DNV's 750t dynamic test rig, which has a servohydraulic 7.5 MN Schenck actuator and an Instron 8500 Plus control panel. The test set-up for the 1500t connector is shown in Figure 5 and Figure 6.

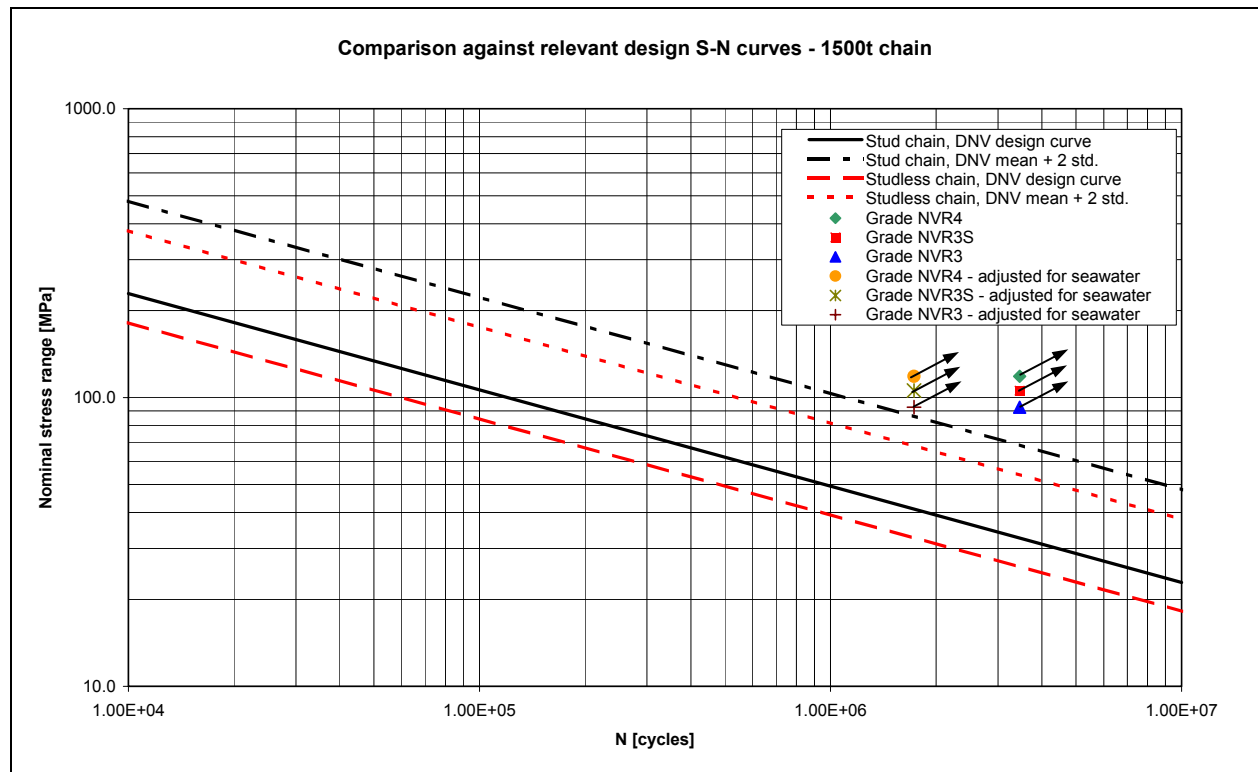
Figure 7 Corresponding chain stress ranges derived from test results.

The results in Table 8, Table 9 and Figure 7 are presented as the stress range in a chain connected to the anchor connector, i.e. the chain and the connector are subject to the same dynamic load because they are linked together. The chain will therefore have to have a fatigue capacity as presented, to be able to withstand the same fatigue loading as the connector.

The results presented in Figure 7 shows that the corresponding stresses in the different types of chains are exceeding the design curves and also the derived upper bound curves (mean + 2 standard deviations). There were no indications of failure of the 1500t anchor connector, and the safety margins may therefore be even bigger. However, the results presented in this report should be evaluated together with the tests that are going to be carried out at DNV’s structural laboratories in Bergen. A subsequent failure investigation should also form the basis for the type approval of the 1500t anchor connector.

In Figure 7, all results are plotted together with the DNV design S-N curves and the derived upper bound curves (see chapter 5).

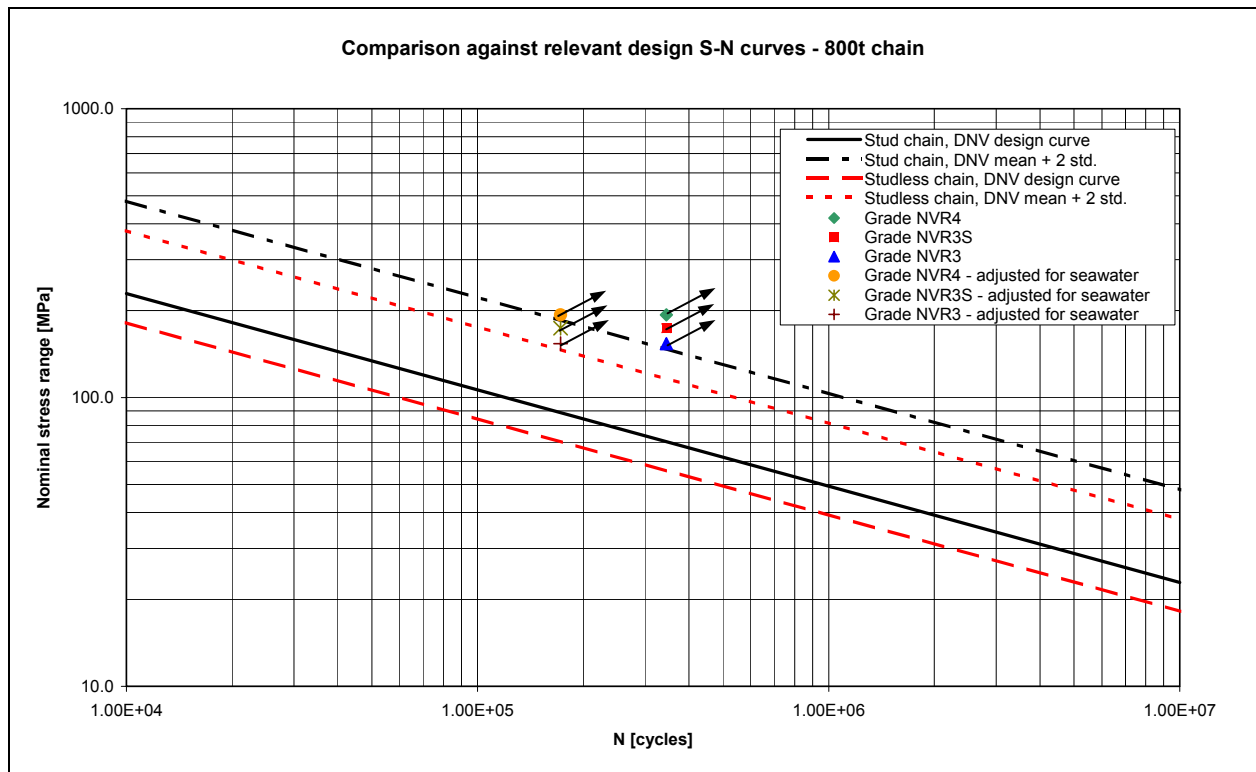
Figure 8 Corresponding chain stress ranges derived from test results.

The results in Table 11, Table 12 and Figure 8 are presented as the stress range in a chain connected to the anchor connector, i.e. the chain and the connector are subject to the same dynamic load because they are linked together. The chain will therefore have to have a fatigue capacity as presented, to be able to withstand the same fatigue loading as the connector.

The results presented in Figure 8 shows that the corresponding stresses in the different types of chains are exceeding the two design curves and the derived upper bound curve for studless chain. The upper bound curve for stud chain is not exceeded for the corresponding chain stress ranges that are adjusted for seawater. It should be noted that there were no indications of failure of the 800t anchor connector, and the capacity of the connector may therefore be larger.

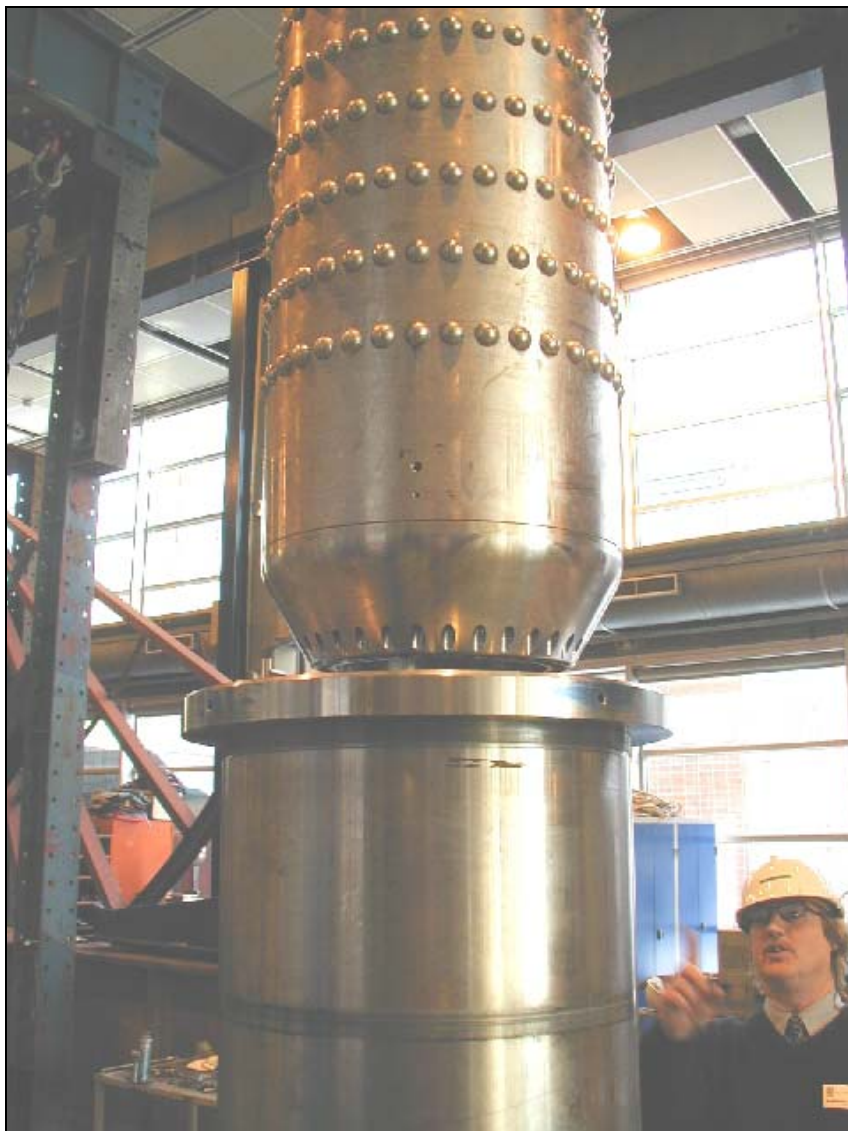
Figure 10 Mandrel being connected with receptacle.

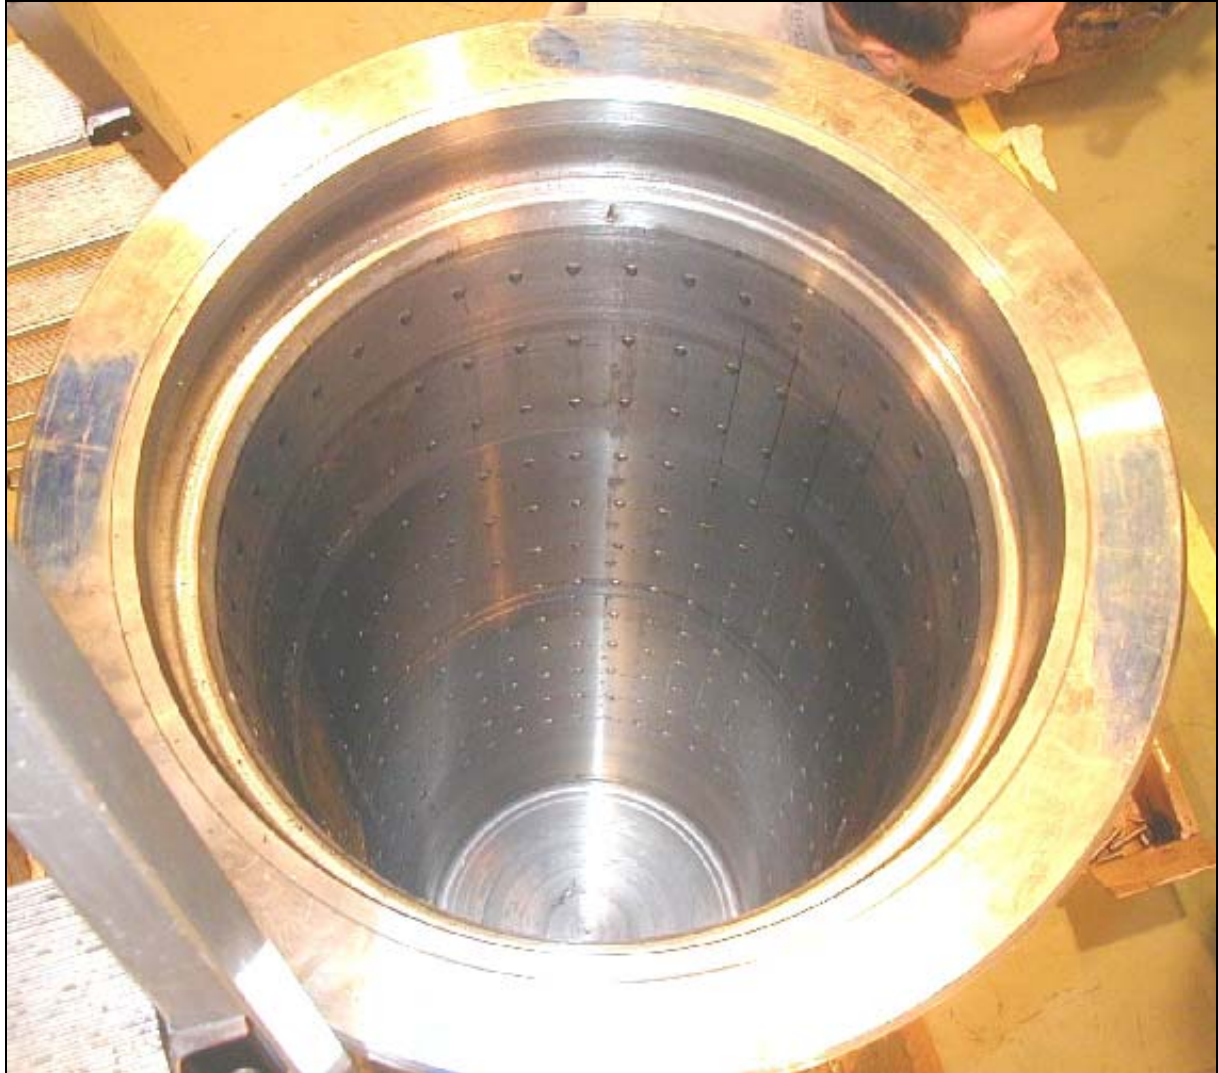
Figure 11 Indents in the receptacle after functionality test.

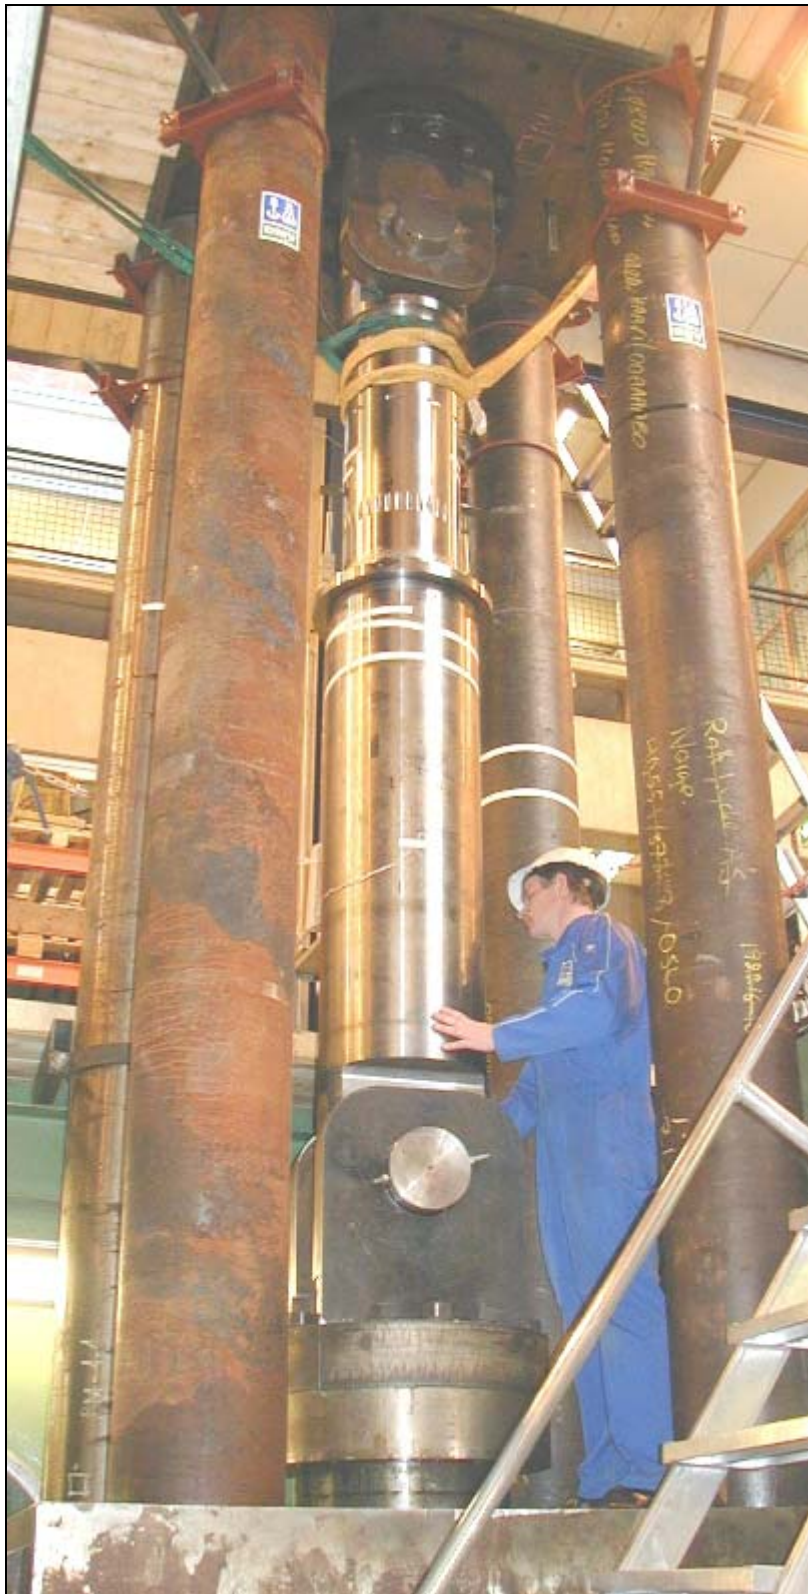
Figure 14 Anchor connector installed in test rig (with two rows of balls).

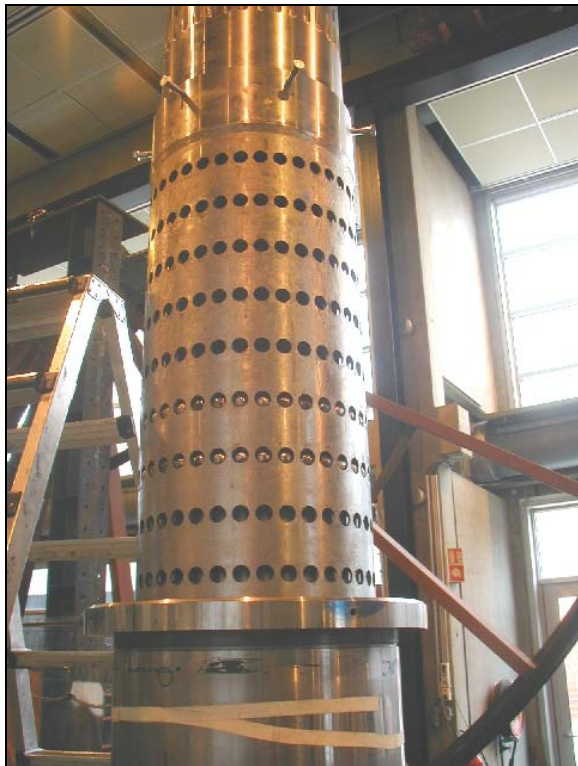
Figure 15 Mandrel being taken out of receptacle after testing.

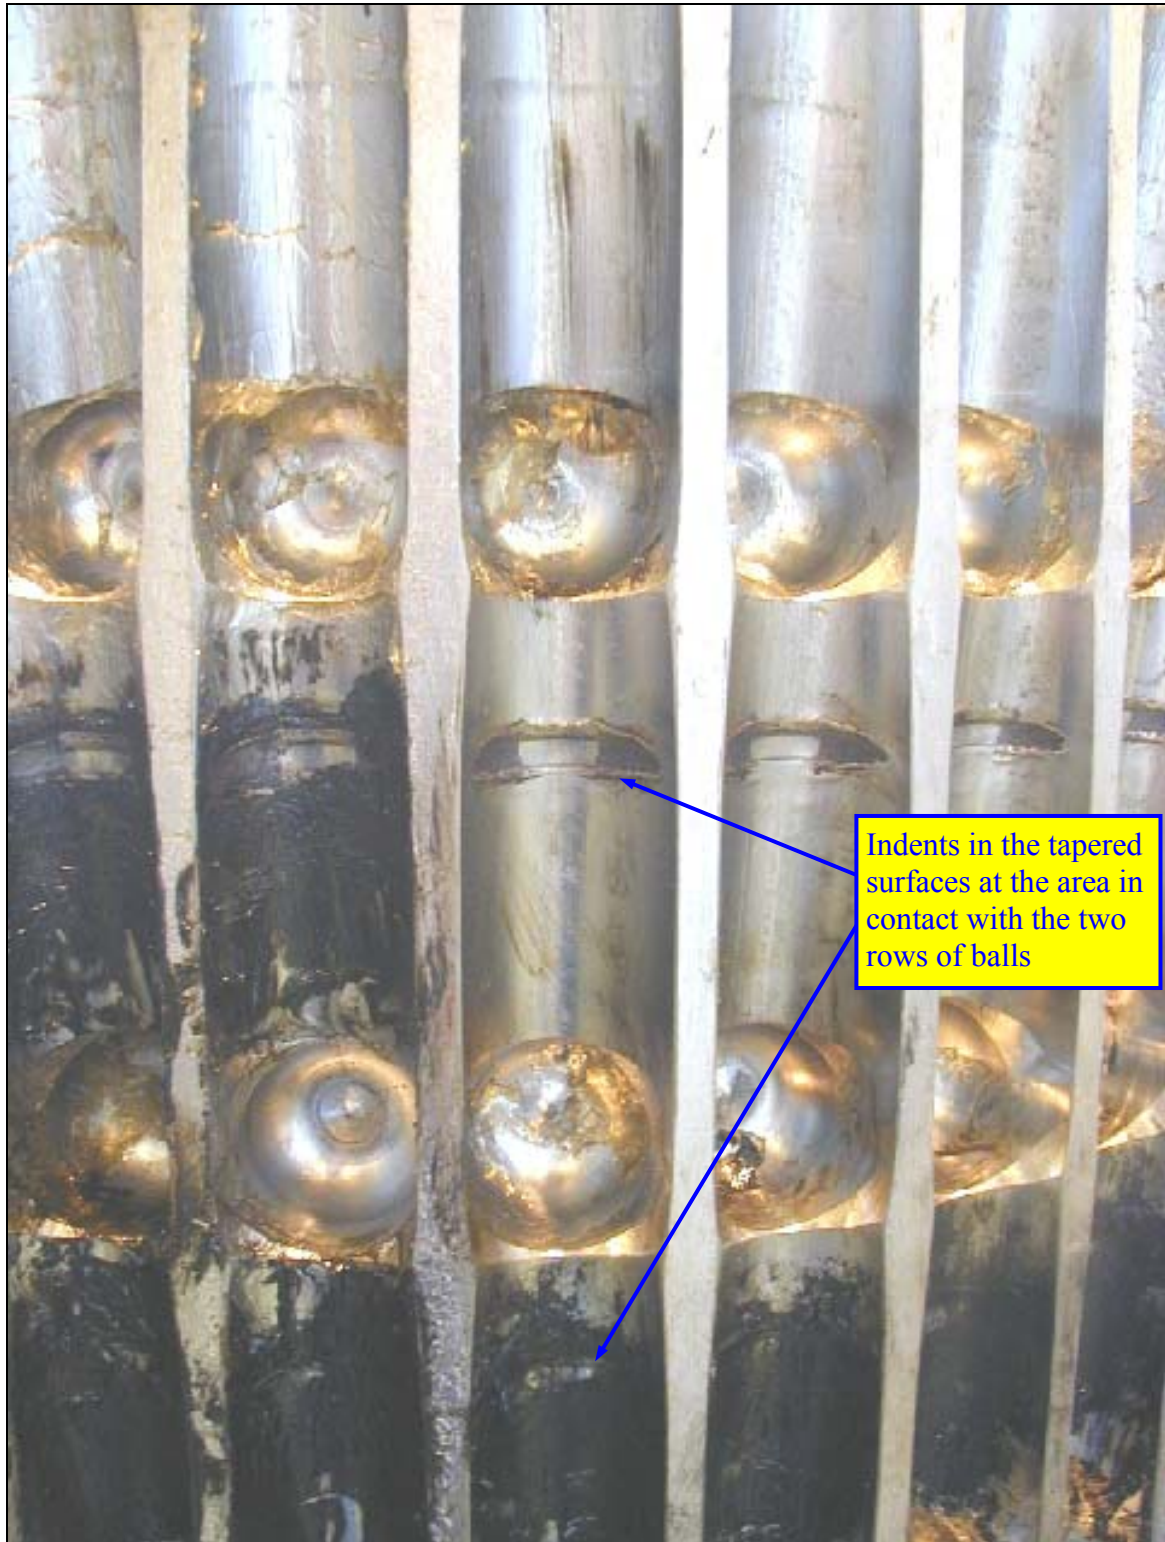
Figure 17 Close-up of tapered surfaces on mandrel after testing.

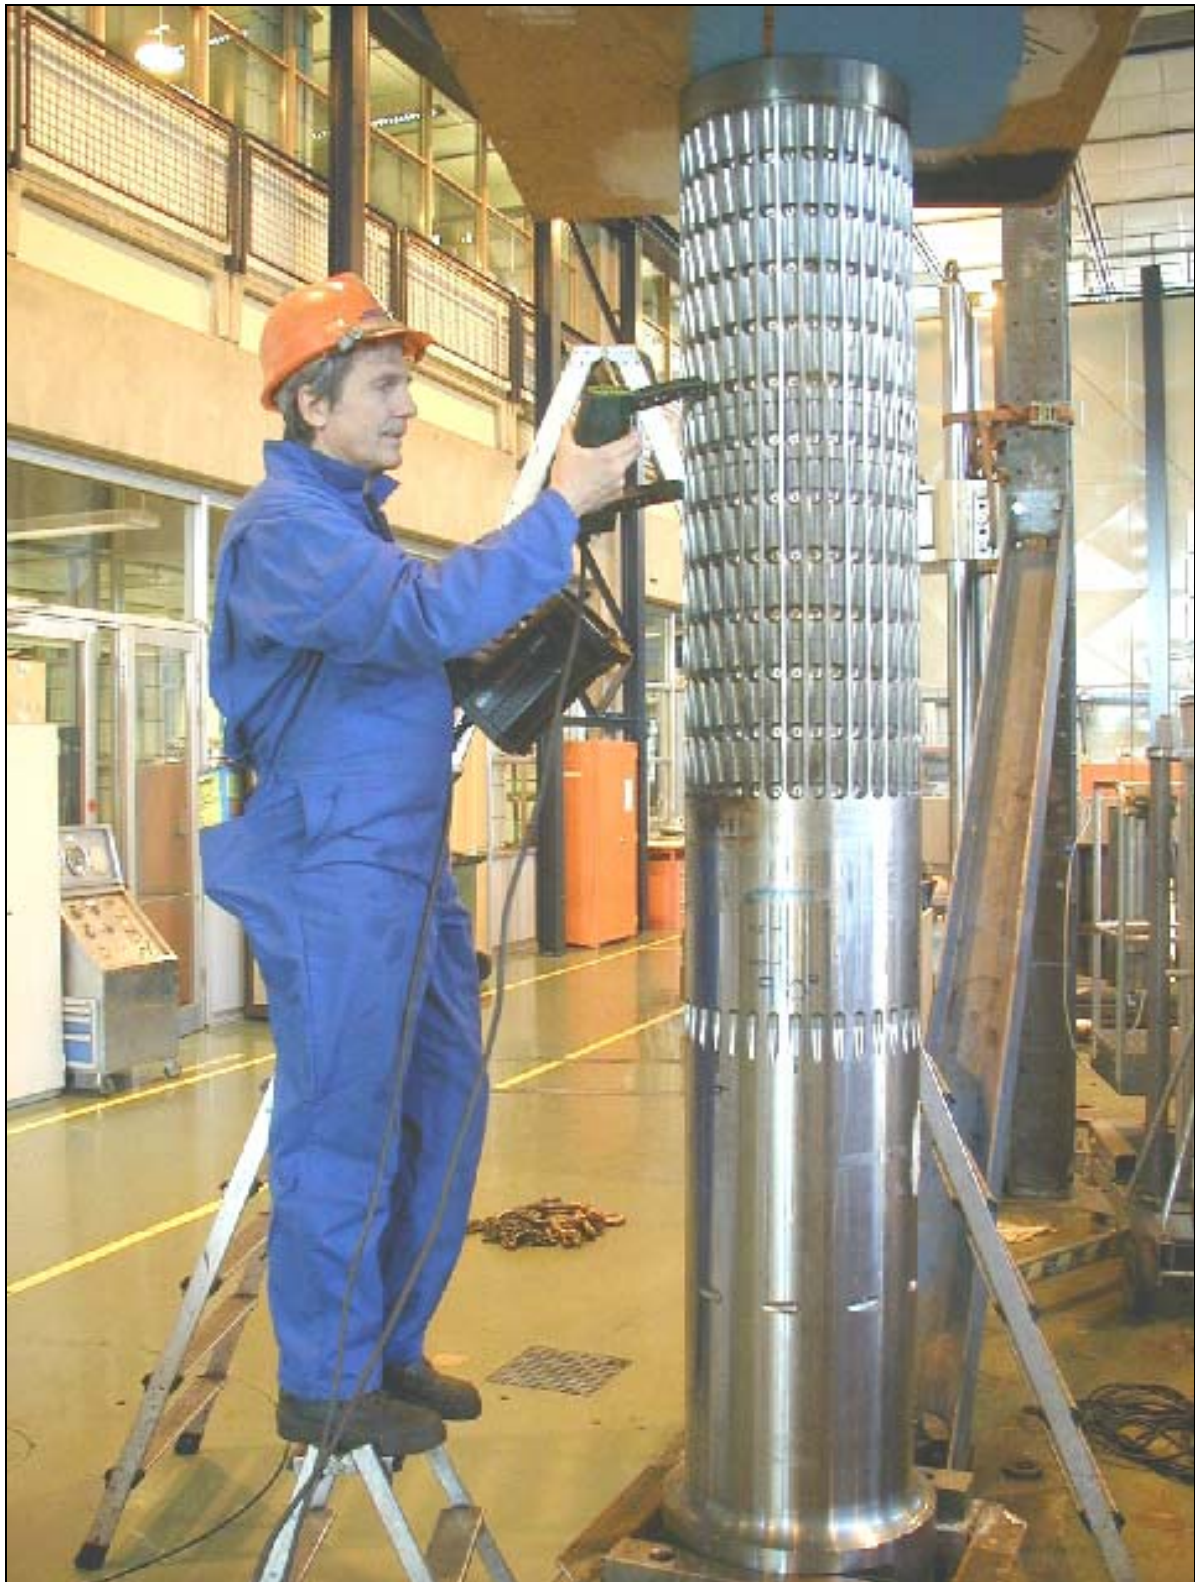
Figure 20 Magnetic particle inspection (MPI) after testing.

The test was stopped at 2.61 million load cycles, although there were no indications of failure. Magnetic particle inspection was carried out on the mandrel and the receptacle, in the area subject to contact from the two rows of balls. No cracks were found in the surfaces (see Appendix C).

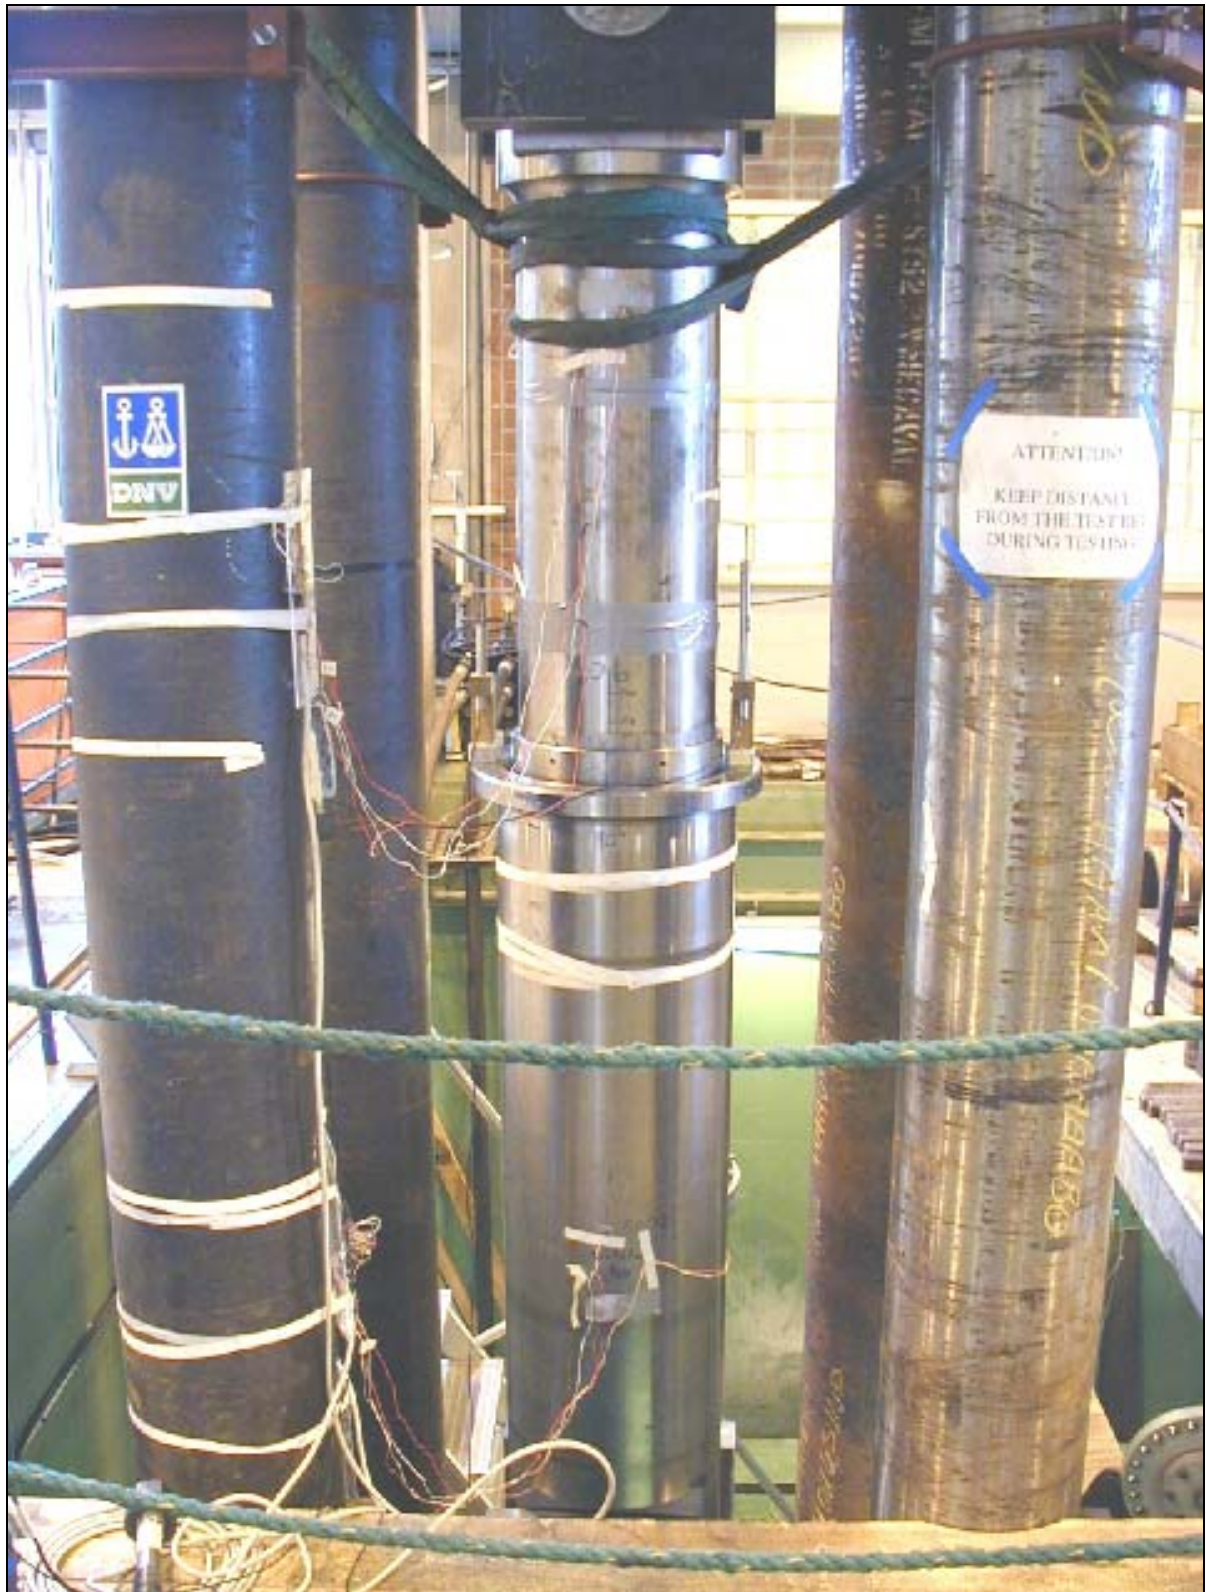
Figure 21 Anchor connector installed in test rig.

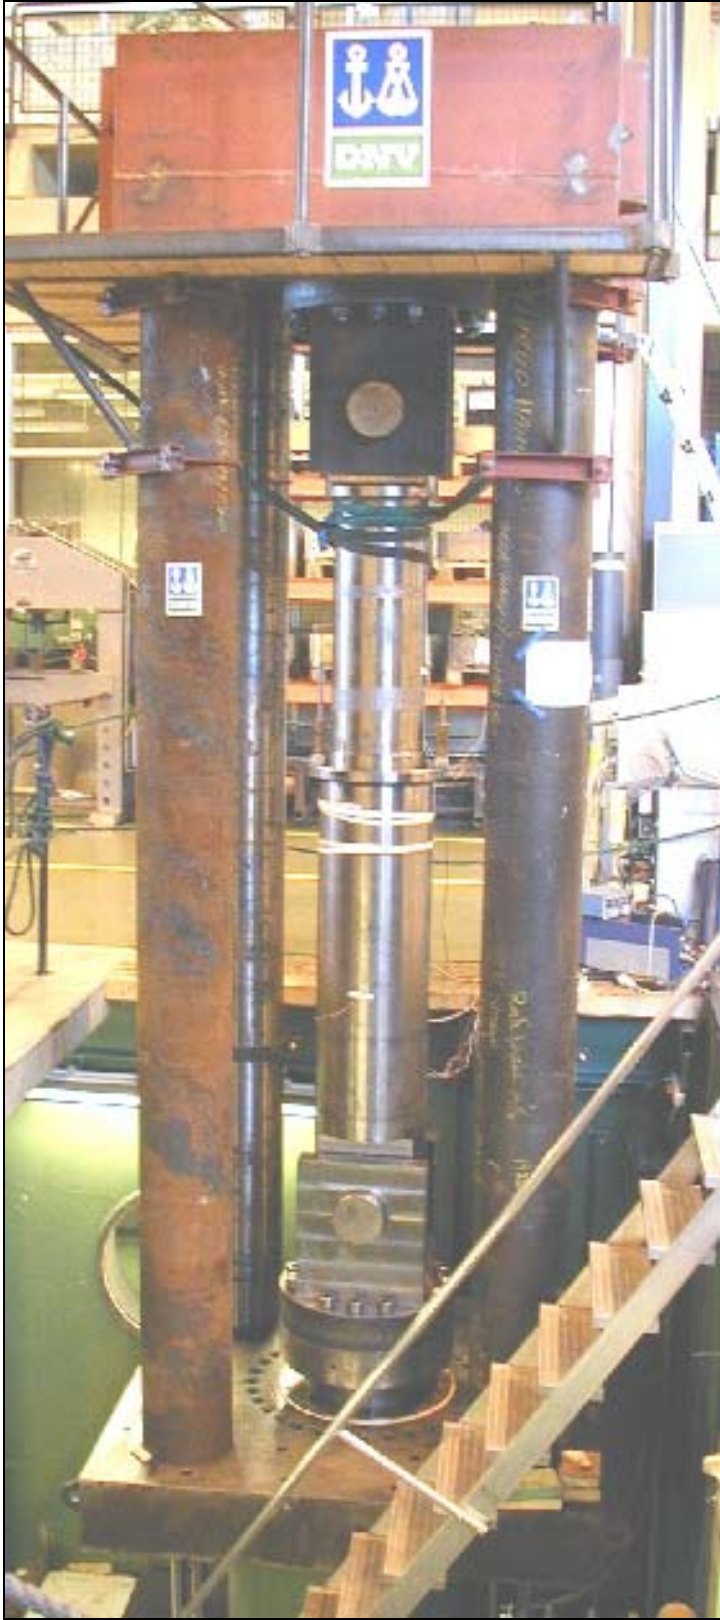
Figure 22 Anchor connector installed in test rig.

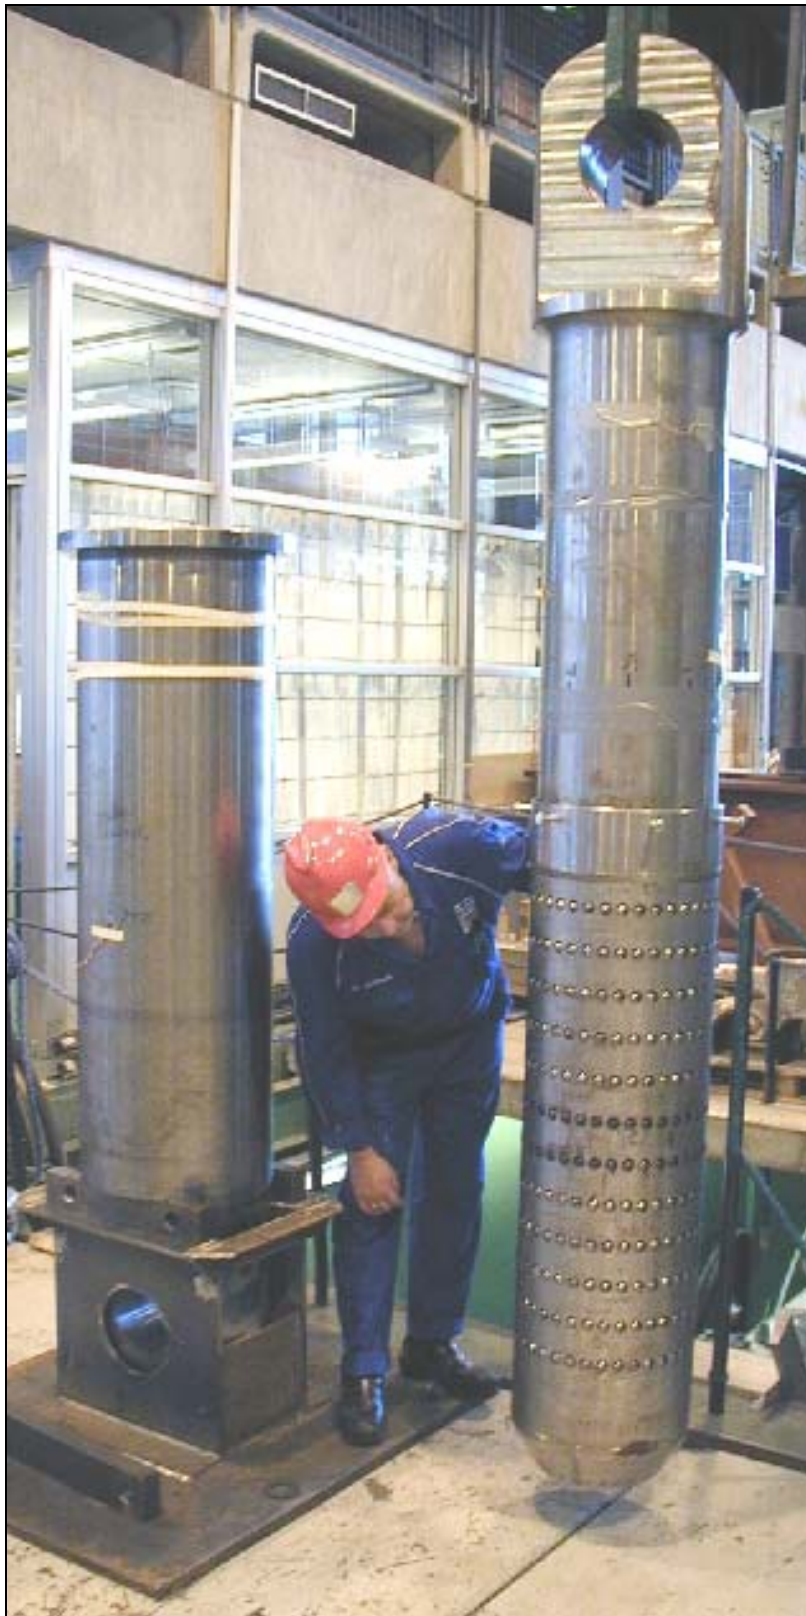
Figure 23 Anchor connector disassembled after testing.

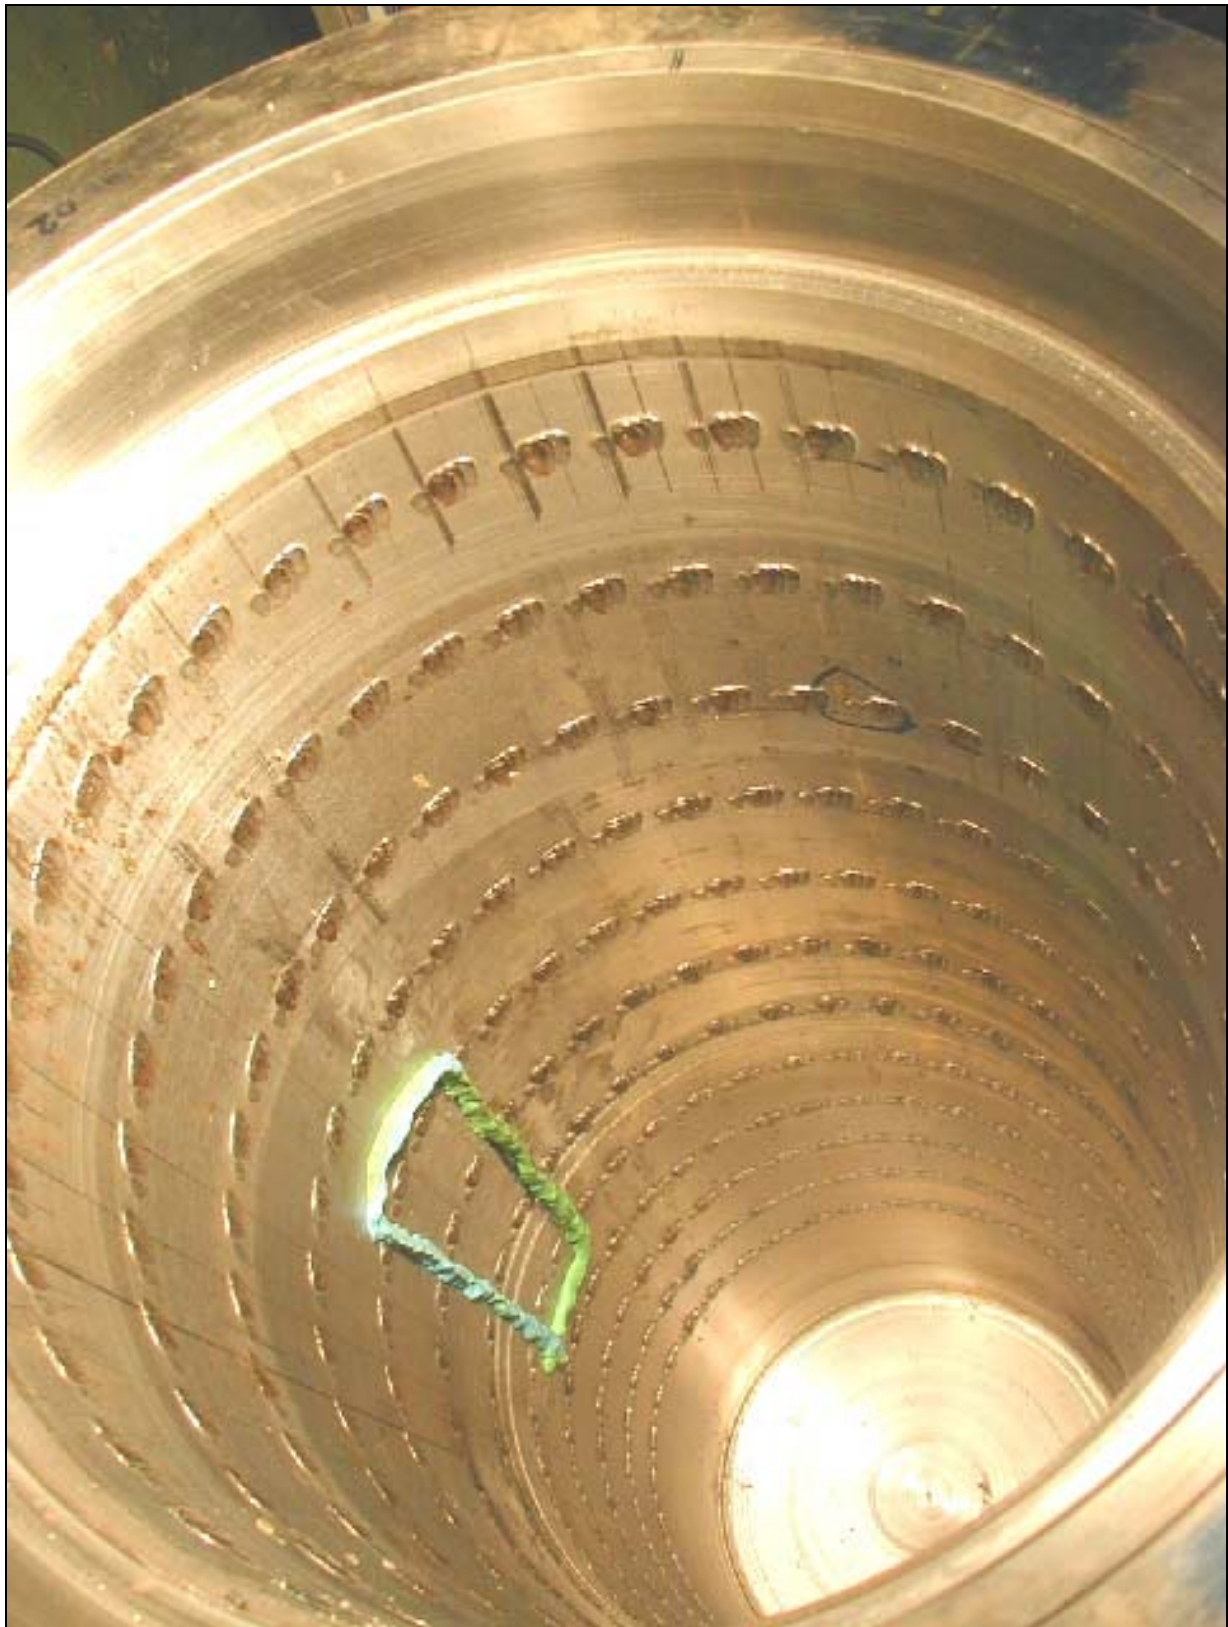
Figure 24 Indents inside of receptacle after testing.

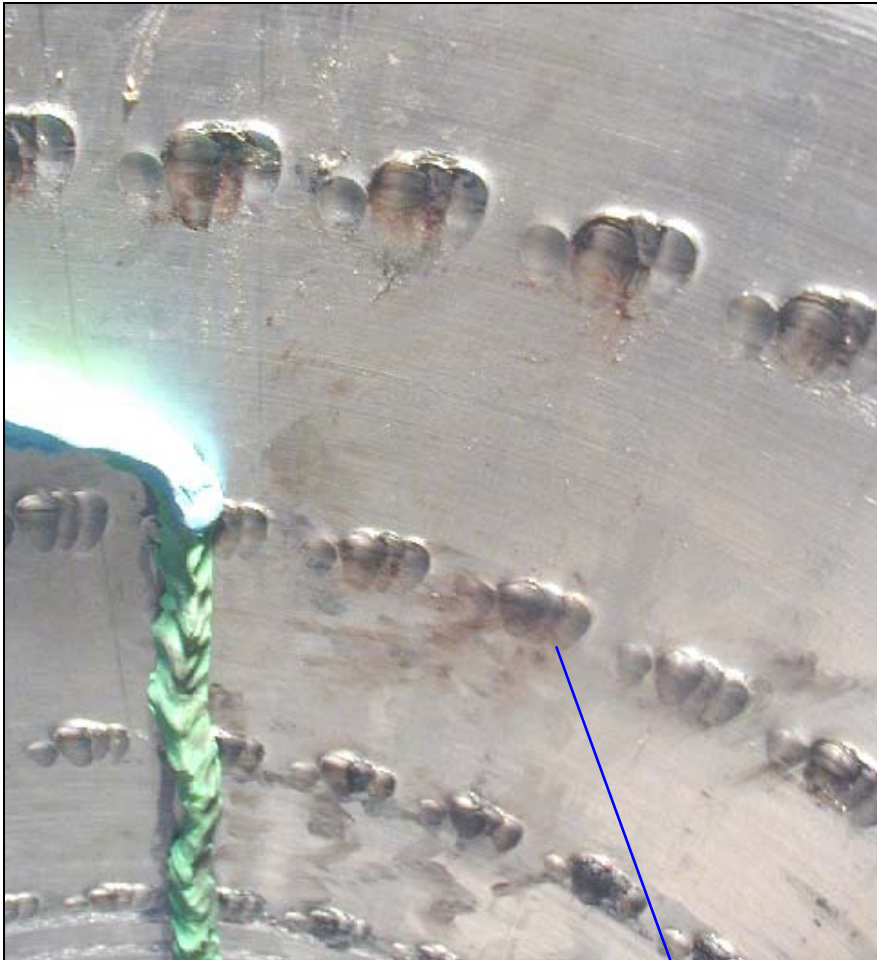
Figure 25 Close-up of indents inside of receptacle after testing.

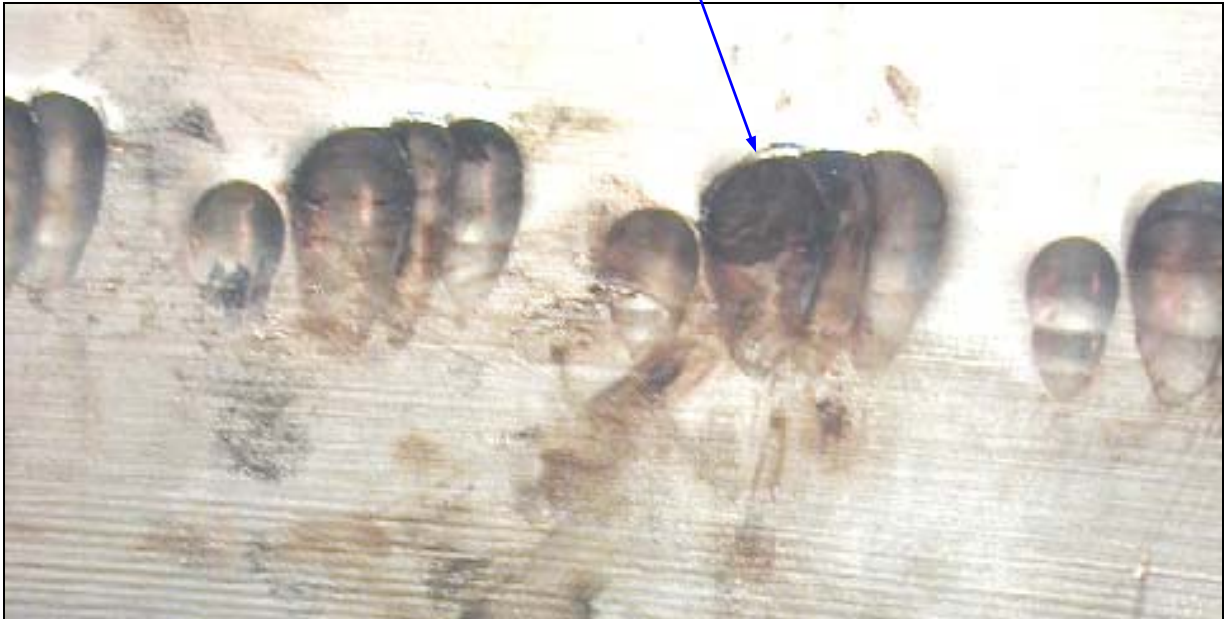
Figure 26 Close-up of indents inside of receptacle after testing.
