TESTING OF BALLGRAB ANCHOR CONNECTOR

REPORT No. 2002-3263

DET NORSKE VERITAS

Date of first issue: 2002-07-31	Project No.: 71521012	DET NORSKE VERITAS REGION NORGE AS <i>Structural Integrity and Laboratories</i> Veritasveien 1, N-1322 HØVIK, Norway Tel: +47 67 57 99 00 Fax: +47 67 57 99 11 http://www.dnv.com Org.No: NO 959 627 606 MVA
Approved by: Elisabeth Heggelund Tørstad Head of Section	Organisational unit: Structural Integrity and Laboratories	
Client: BSW Limited Design & Engineering	Client ref.: Ian Brown

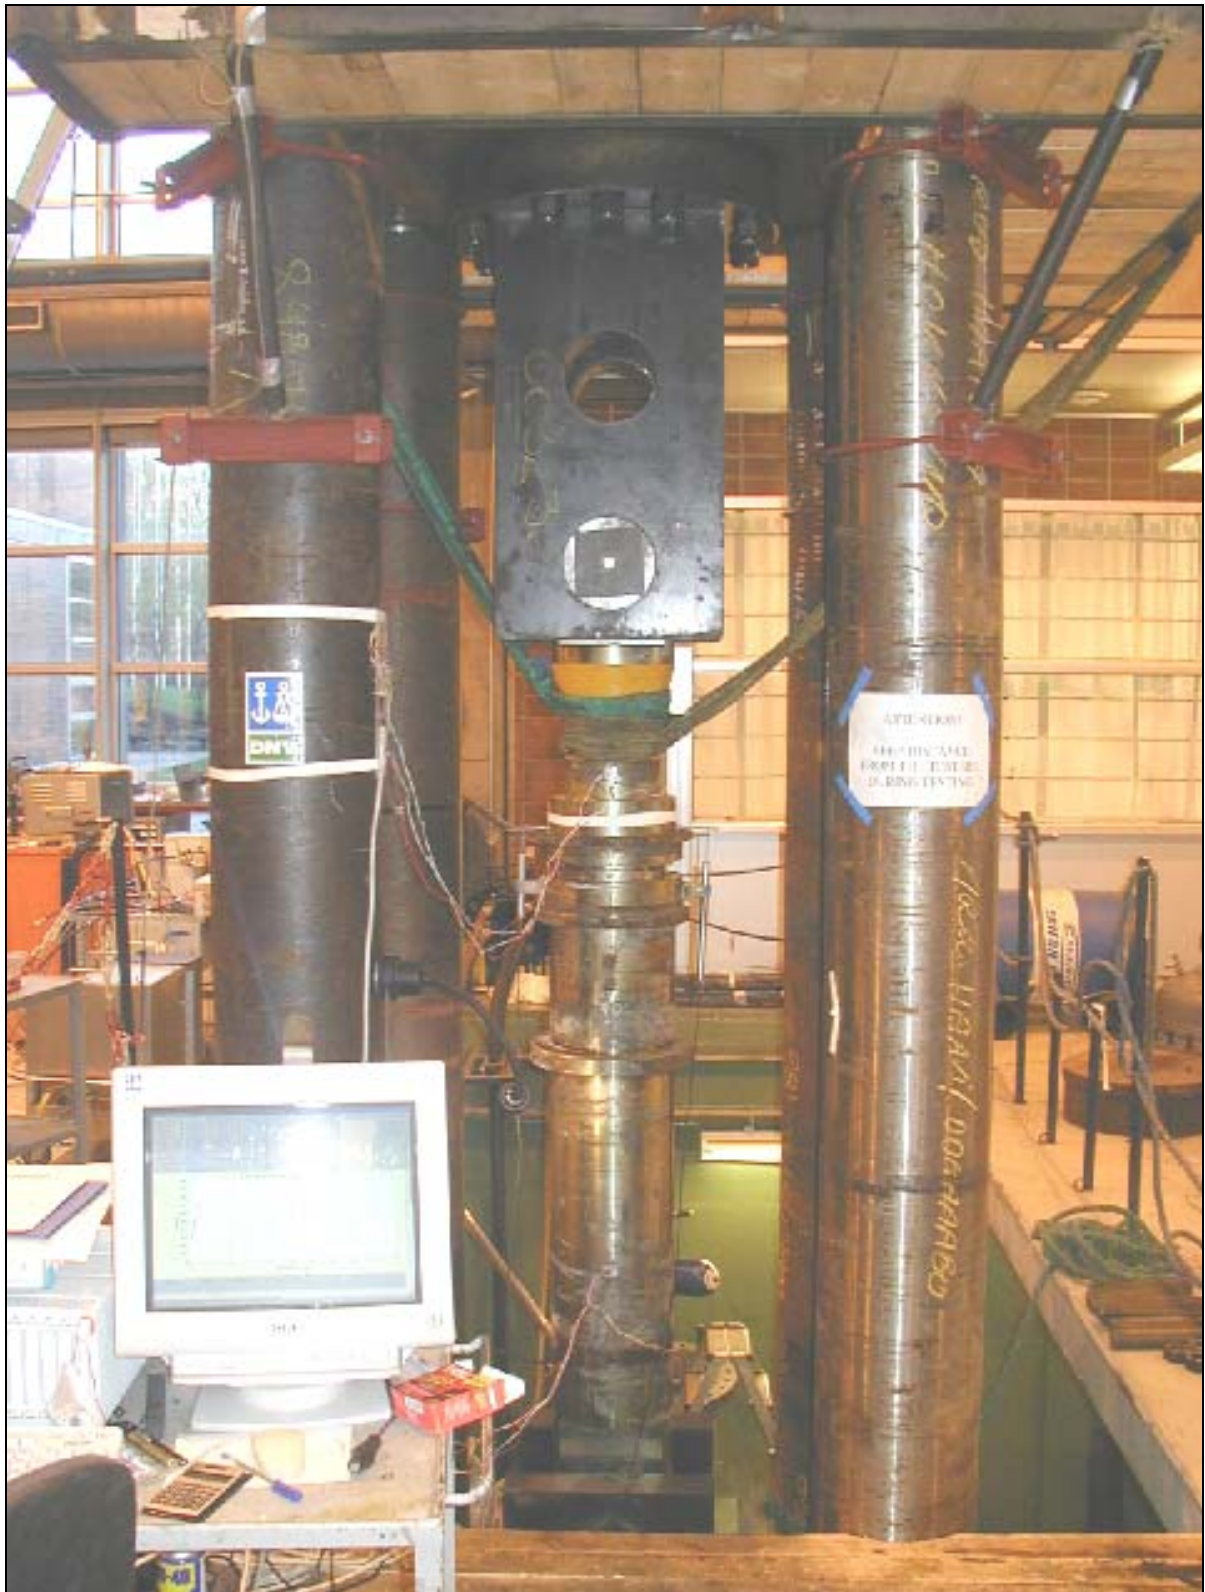
Figure 27 Anchor connector installed in test rig.

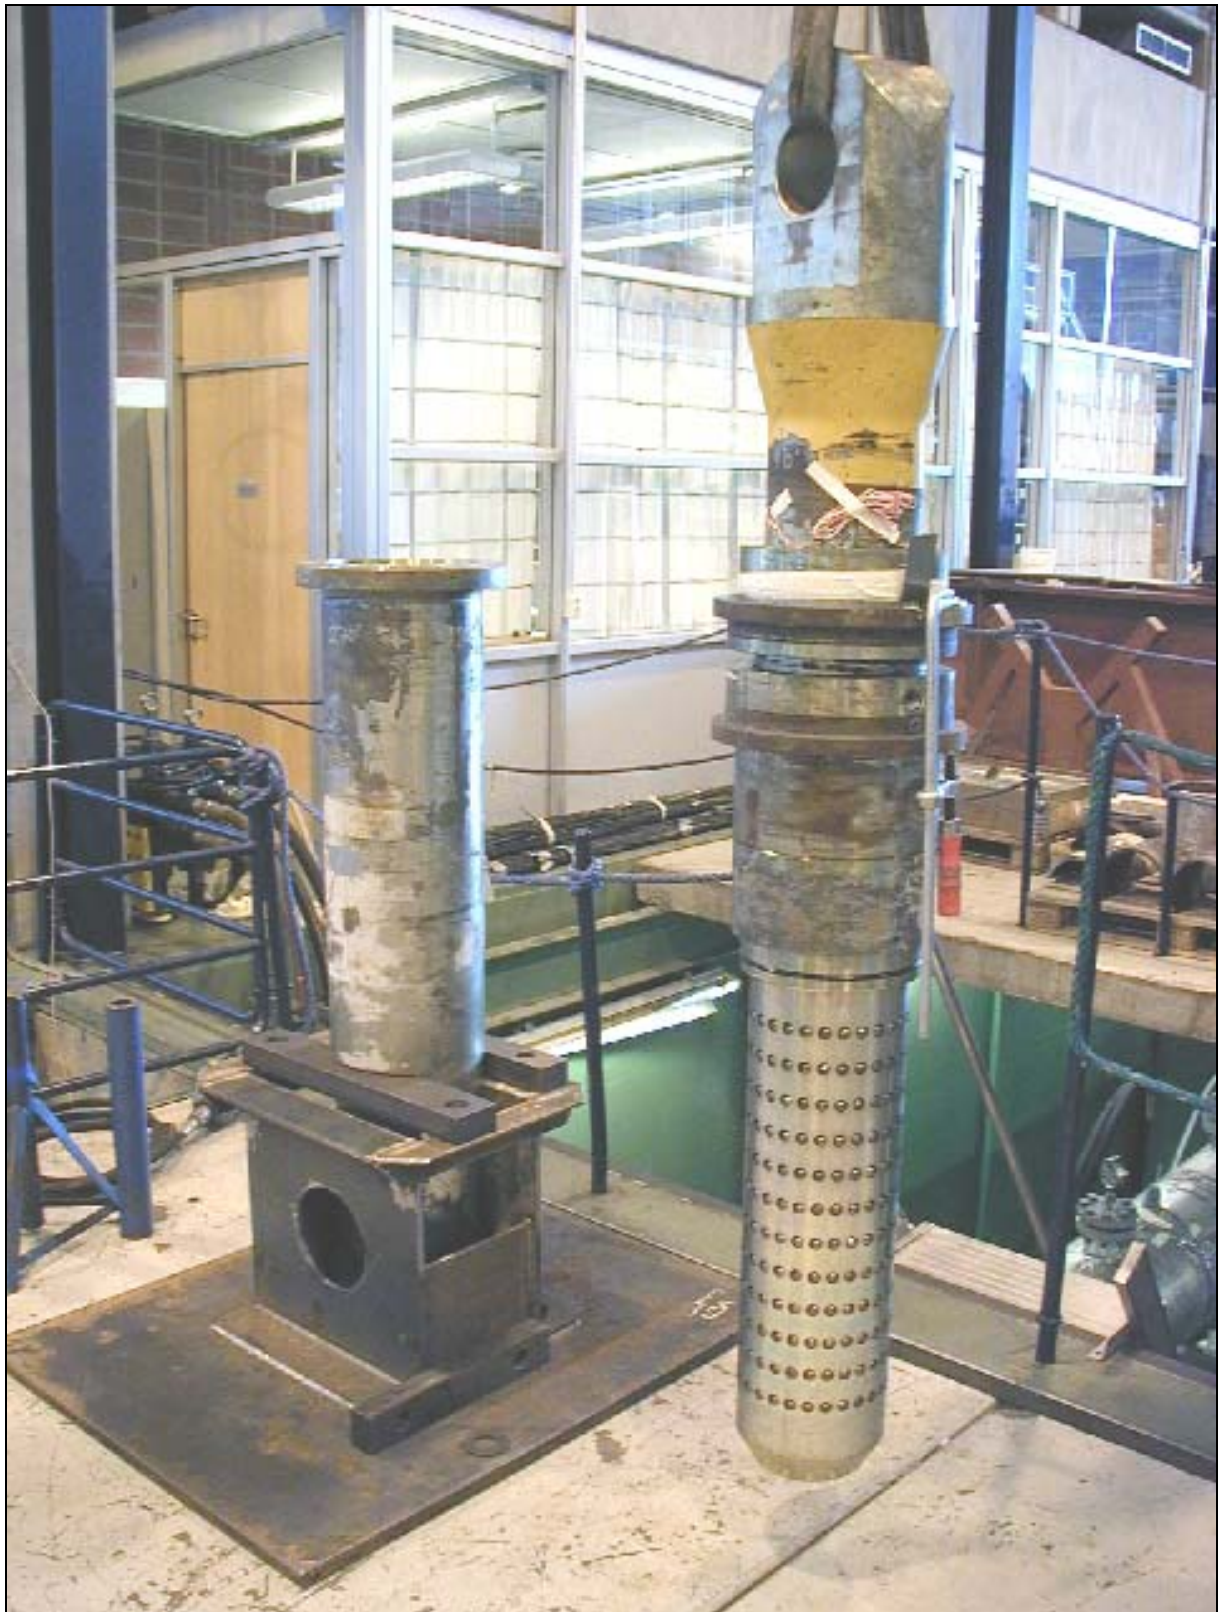
Figure 28 Anchor connector disassembled after testing.

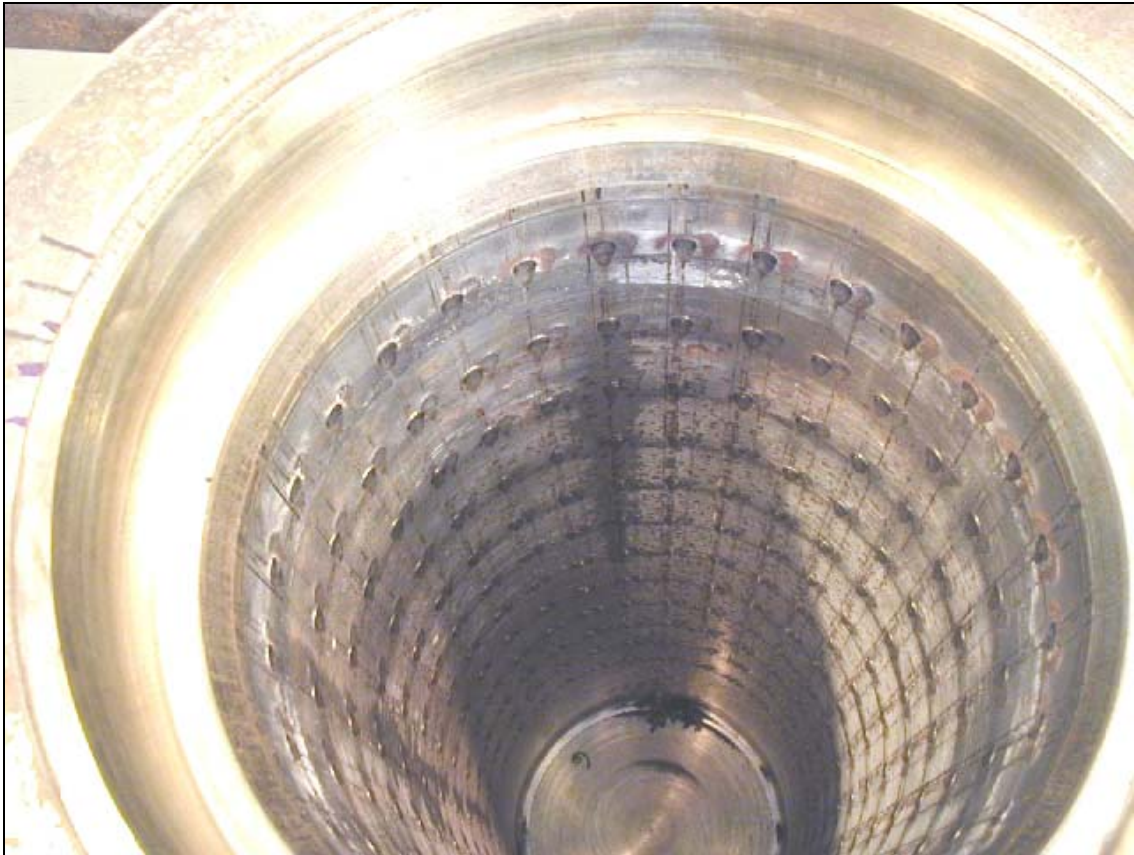
Figure 29 Indents inside of receptacle after testing.
